T-391  
Lindemann Farm  
30742 Skipton Cordova Road  
Cordova Vicinity  
Ca. 1920-1960  
Private

# Maryland Historical Trust Maryland Inventory of Historic Properties Form

Inventory No. T-391

historic Lindemann Farm

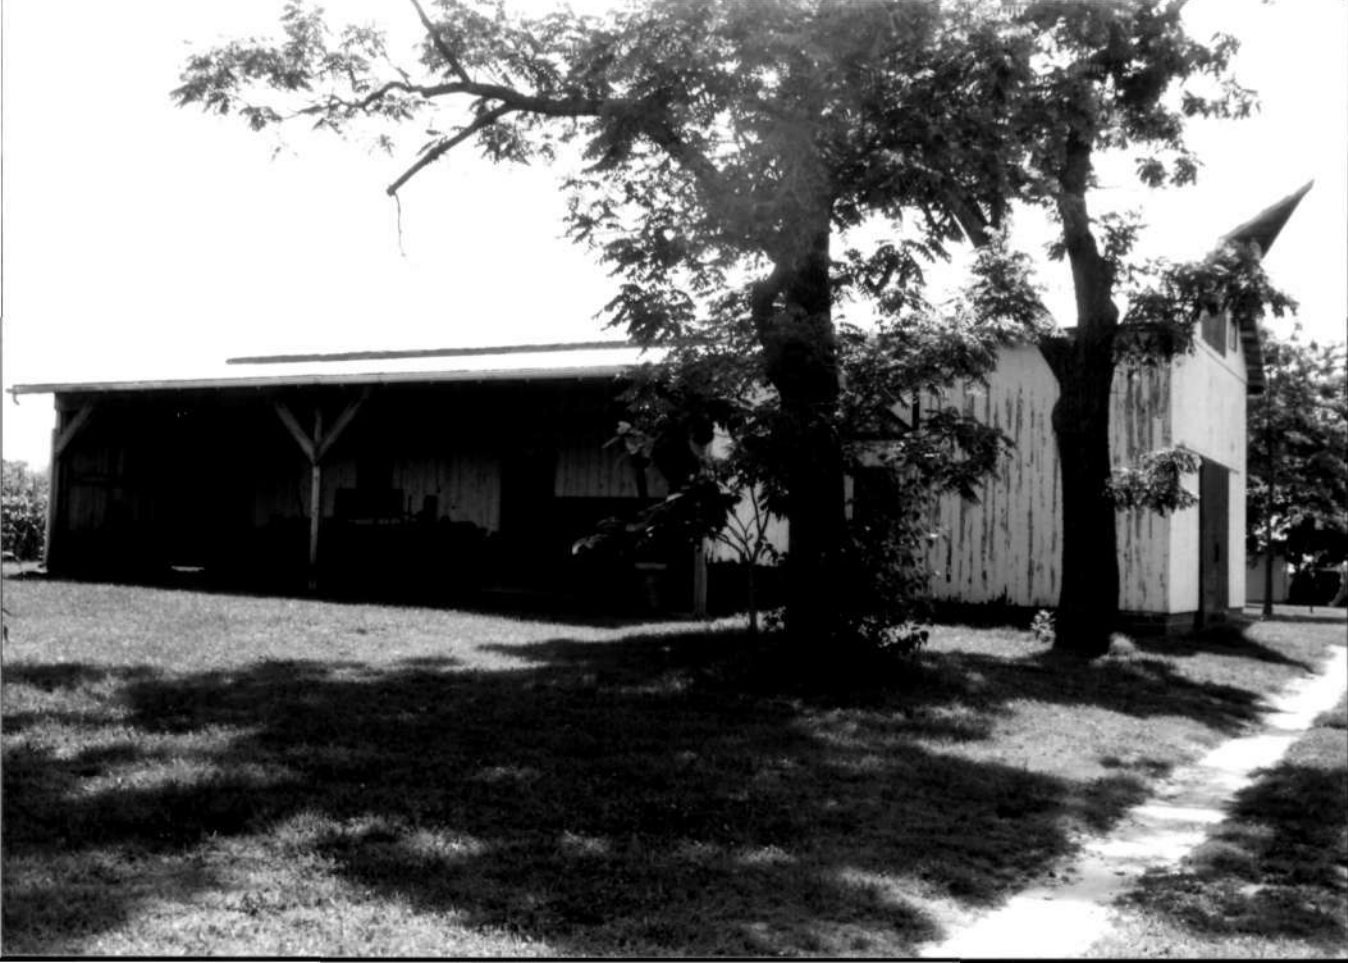
1/14

The multi-purpose barn, constructed prior to 1937, is three bays deep with a hayloft and a ca. 1945 addition built to accommodate a hay fork. The structure rests on a brick masonry pier foundation. The timber frame has pegged mortise and tendon joints and was originally clad with board and batten. The building is currently clad with six-inch vertical wood planks. The front-gable roof is clad with standing-seam metal over corrugated metal and, on the oldest portion, wood shingles. The barn has a hay hood on the south gable end. The Dutch doors are hinged wood plank with diagonal bracing. Sliding wood plank doors are located on the gable ends. The windows are two-pane steel hopper sashes. The interior of the building is unfinished with an earthen floor and wood animal pens. There is a two bay shed roof machine shed addition on the west façade.

Barn exterior looking E

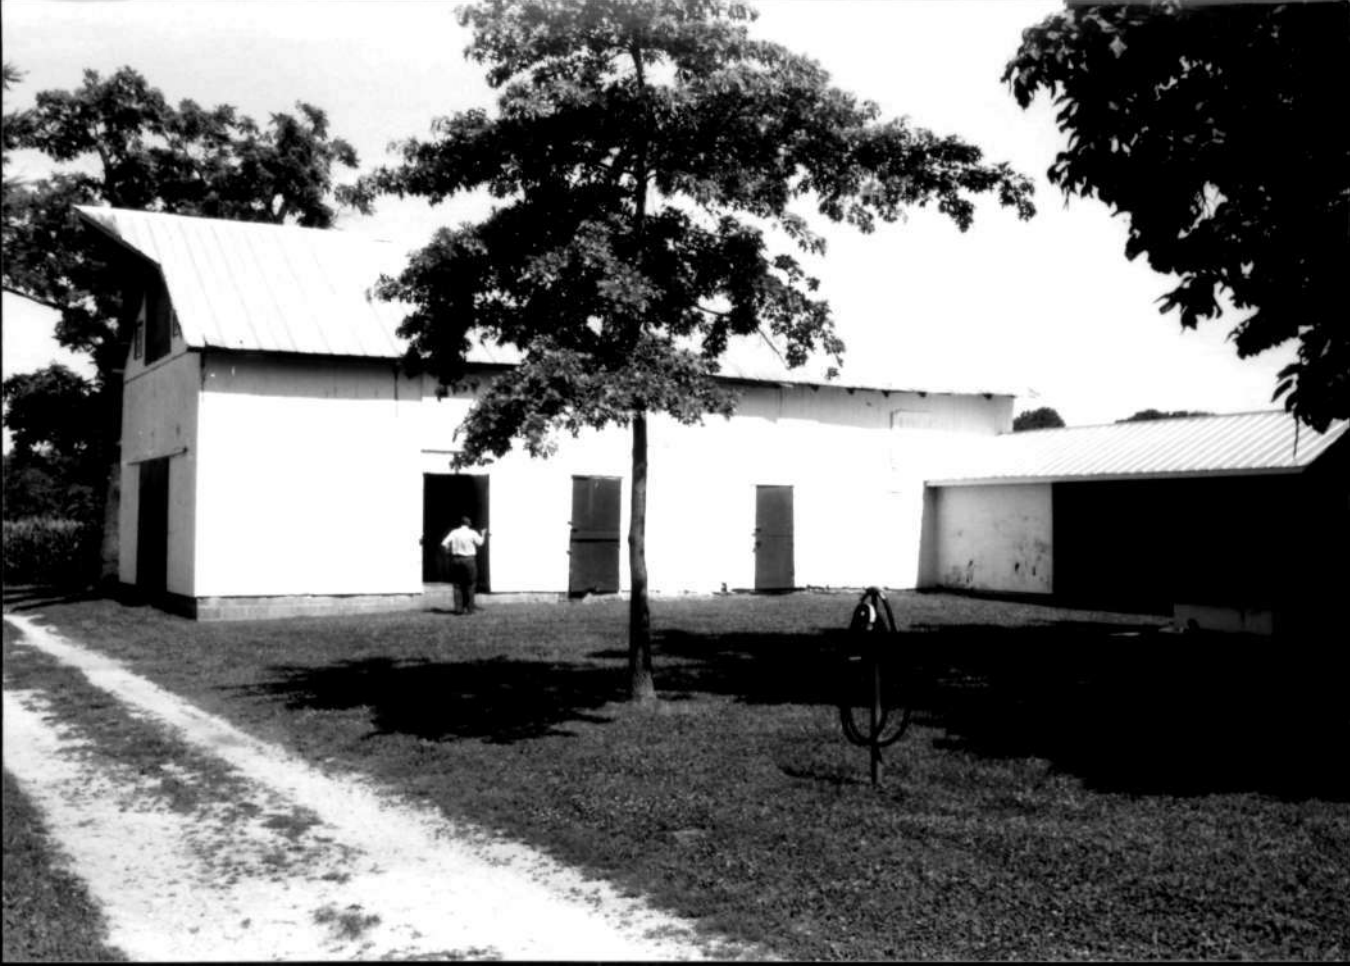
2/14

Barn exterior looking N

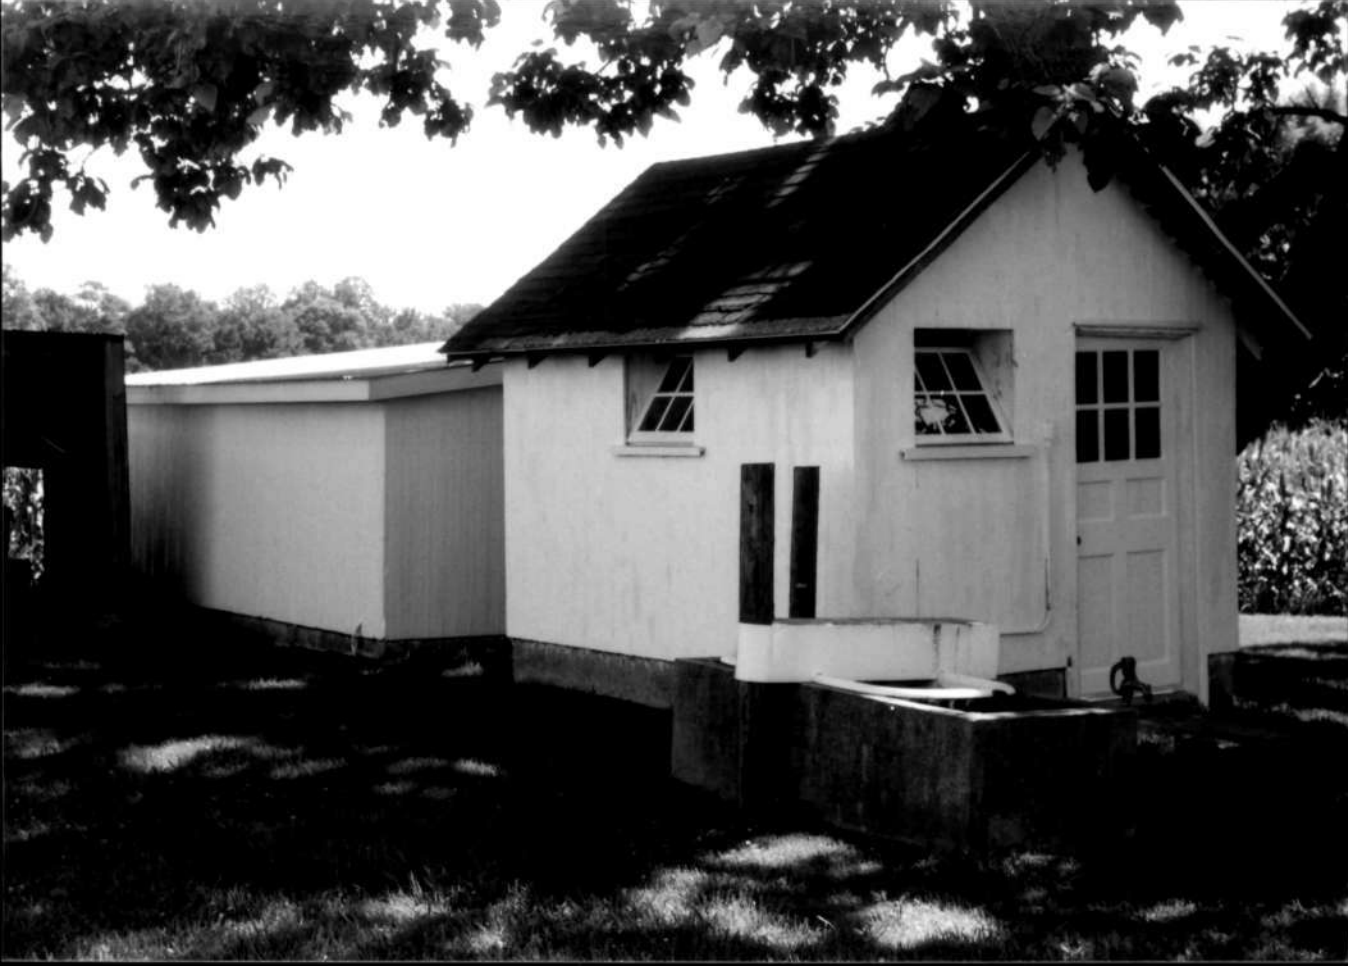
5/14

Adjacent to the cattle shed is the chicken house, constructed prior to 1937, which was converted into a hog house in the 1950s and is currently used as a recreation room. The building is a one-story light timber frame structure with an undivided interior space. The building rests on a poured concrete slab with a one-foot curb around the perimeter. The walls are clad with vertical beadboard. The shed roof is clad with corrugated metal. The building is accessed through a hinged two panel nine-pane wood door on the south façade. The window openings have been infilled with a combination of one-over-one vinyl and six-over-six wood sashes. The interior of the building is finished with drywall and has a poured concrete floor.

The milk house is located south of the chicken house. The ca. 1937 milk house is a one-story light timber frame structure with an undivided interior space. The building rests on a poured concrete slab. The walls are clad with vertical beadboard. The front-gable roof is clad with asphalt shingles. The building is accessed through a hinged four panel six-pane wood door on the south façade. The windows are six-pane wood hopper sashes. The interior of the building is unfinished with a poured concrete floor. A poured concrete cooling trough is located in the southwest corner of the building and is connected to the exterior well via a set of metal pipes.

Milk house + chicken house looking E

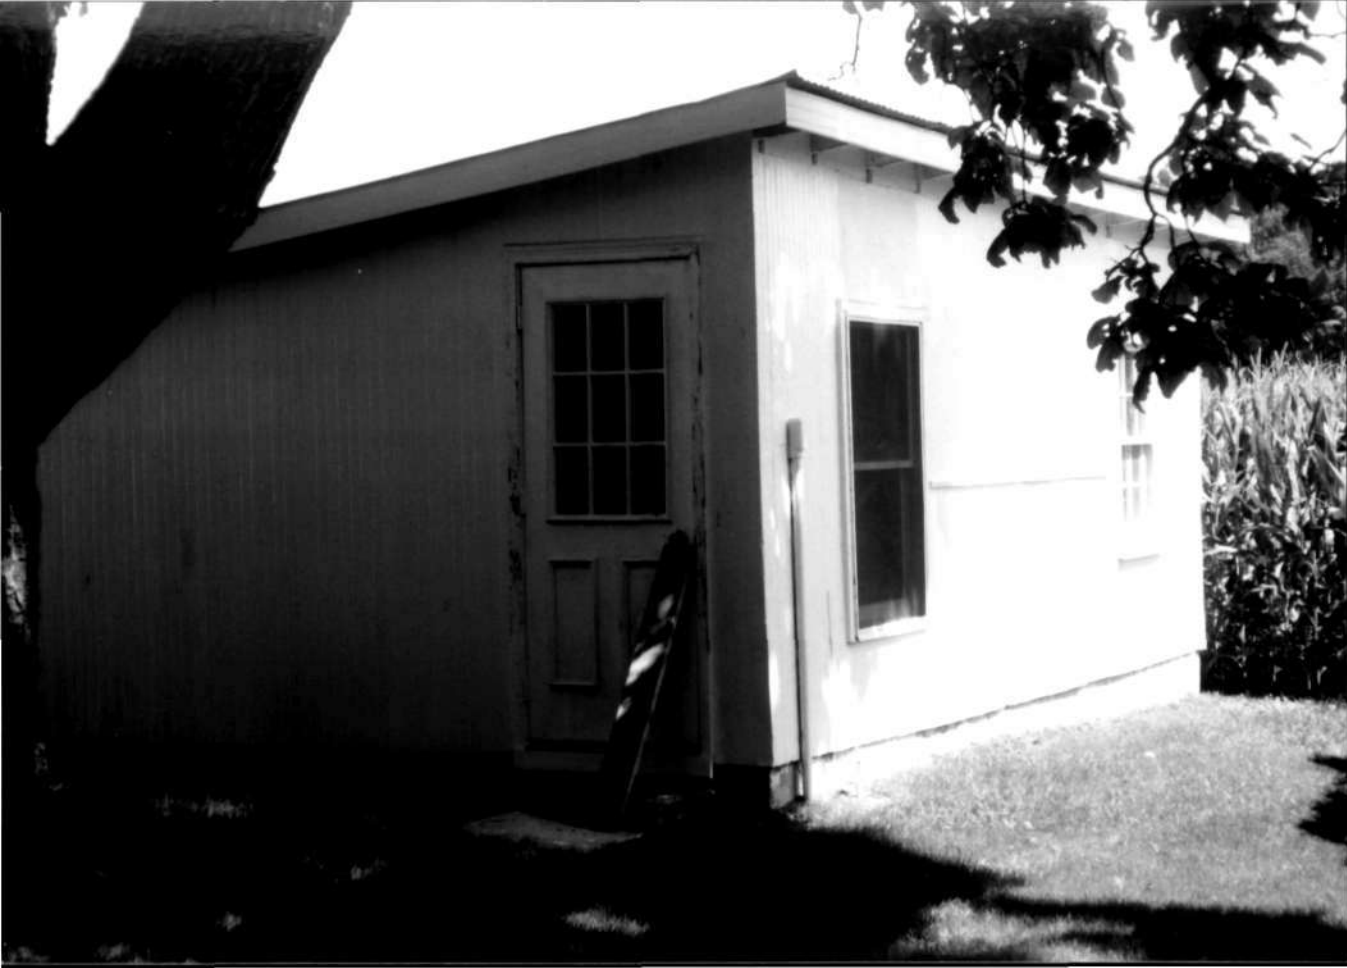
6/14

chicken house looking N

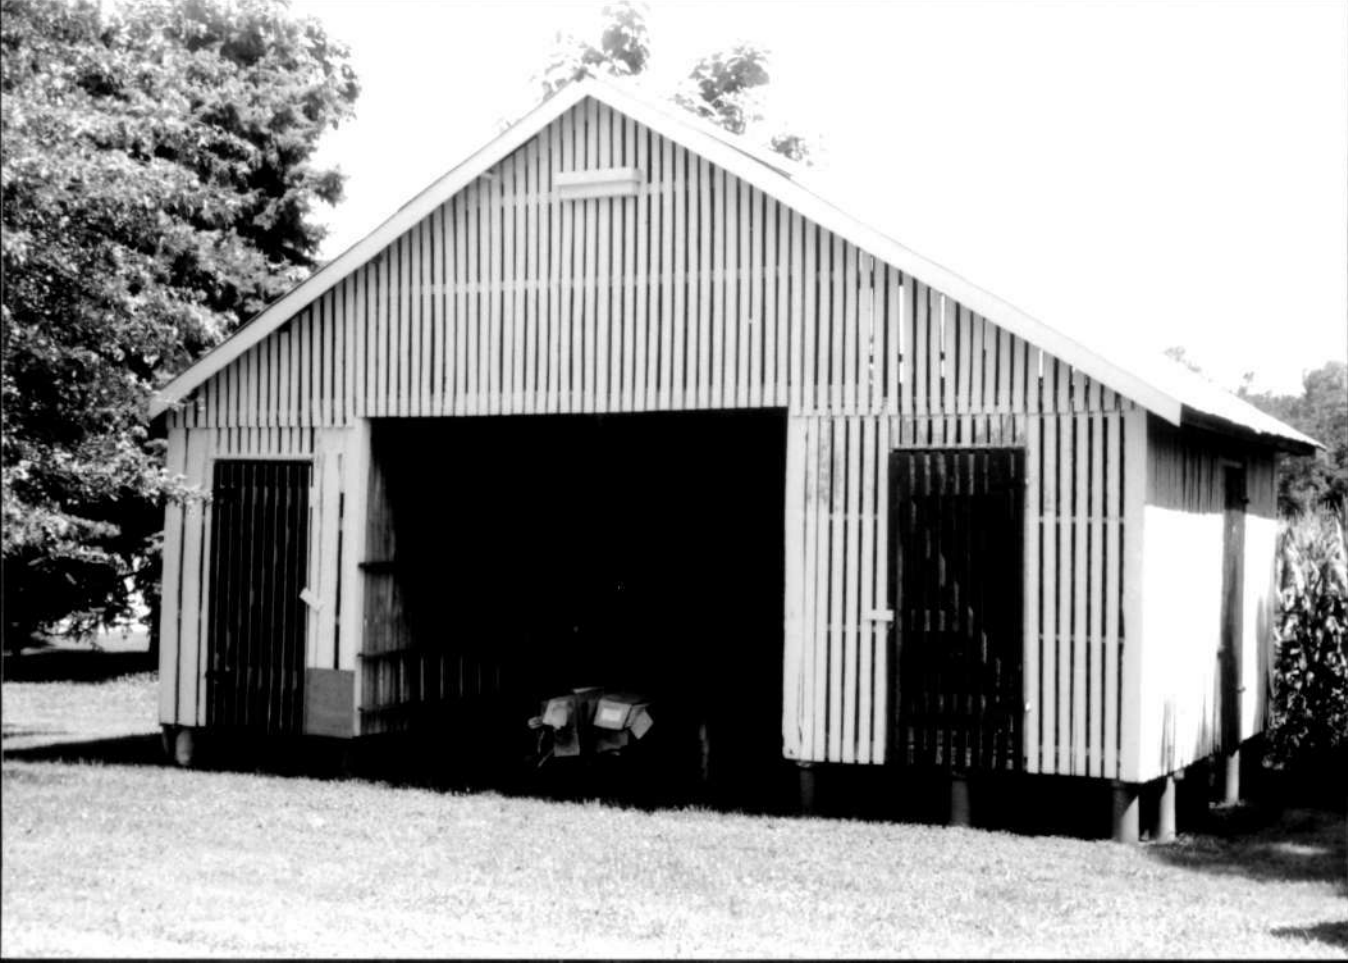
7/14

The drive-thru corncrib is a one-story timber frame structure constructed in two phases. The original eight-foot wide corncrib was constructed in 1942 and has a pier foundation constructed of terra cotta soil pipes. The walls are clad with six inch vertical wood boards, spaced approximately one-inch apart. The crib is accessed through a hinged six inches wood plank door with one-half-inch spacing on the south façade. In 1952, a second crib was constructed to the west of the first. The same construction methods and materials were used, with the only difference being that the second crib is

six-feet wide and is clad with three inch vertical wood boards, spaced approximately 1-inch apart. In 1952, the front-gable roof clad with standing-seam metal was also added, bridging the two cribs. There are no windows. The interior of the building is unfinished with a wood plank floor.

CORN CRIB looking N

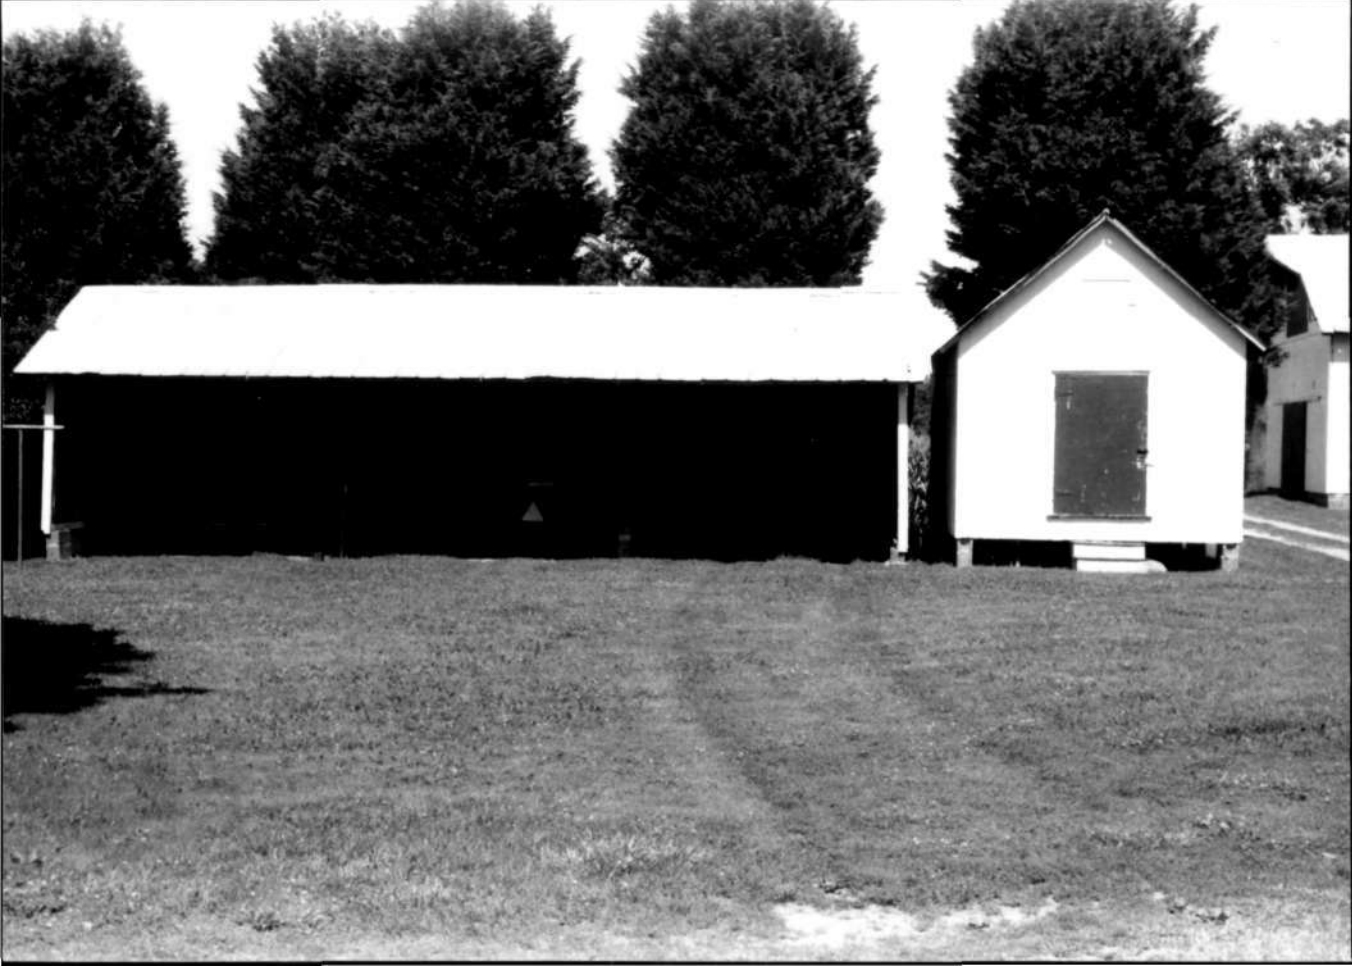
8/14

The implement shed, constructed ca. 1940, is located to the west of the residence, across the access road. It is three bays wide and is of timber frame construction with an open east façade. The shed rests on a combination pier and continuous concrete masonry unit foundation. The walls are clad with vertical wood planks. The side gable roof is clad with standing-seam metal. There are no doors or windows. The interior of the building is unfinished with an earthen floor.

Adjacent to the implement shed is the granary which is a one-story timber frame structure with an undivided interior space. The building rests on a concrete masonry unit pier foundation. The walls are clad with six inch vertical wood planks. The front-gable roof is clad with standing-seam metal. The building is accessed through a hinged plywood panel door on the east façade. There are four three-pane vinyl double sash windows, which were added at a later date. The interior of the building is unfinished with a wood plank floor.

WAGON SHED + GRANAIRY 00K + NW

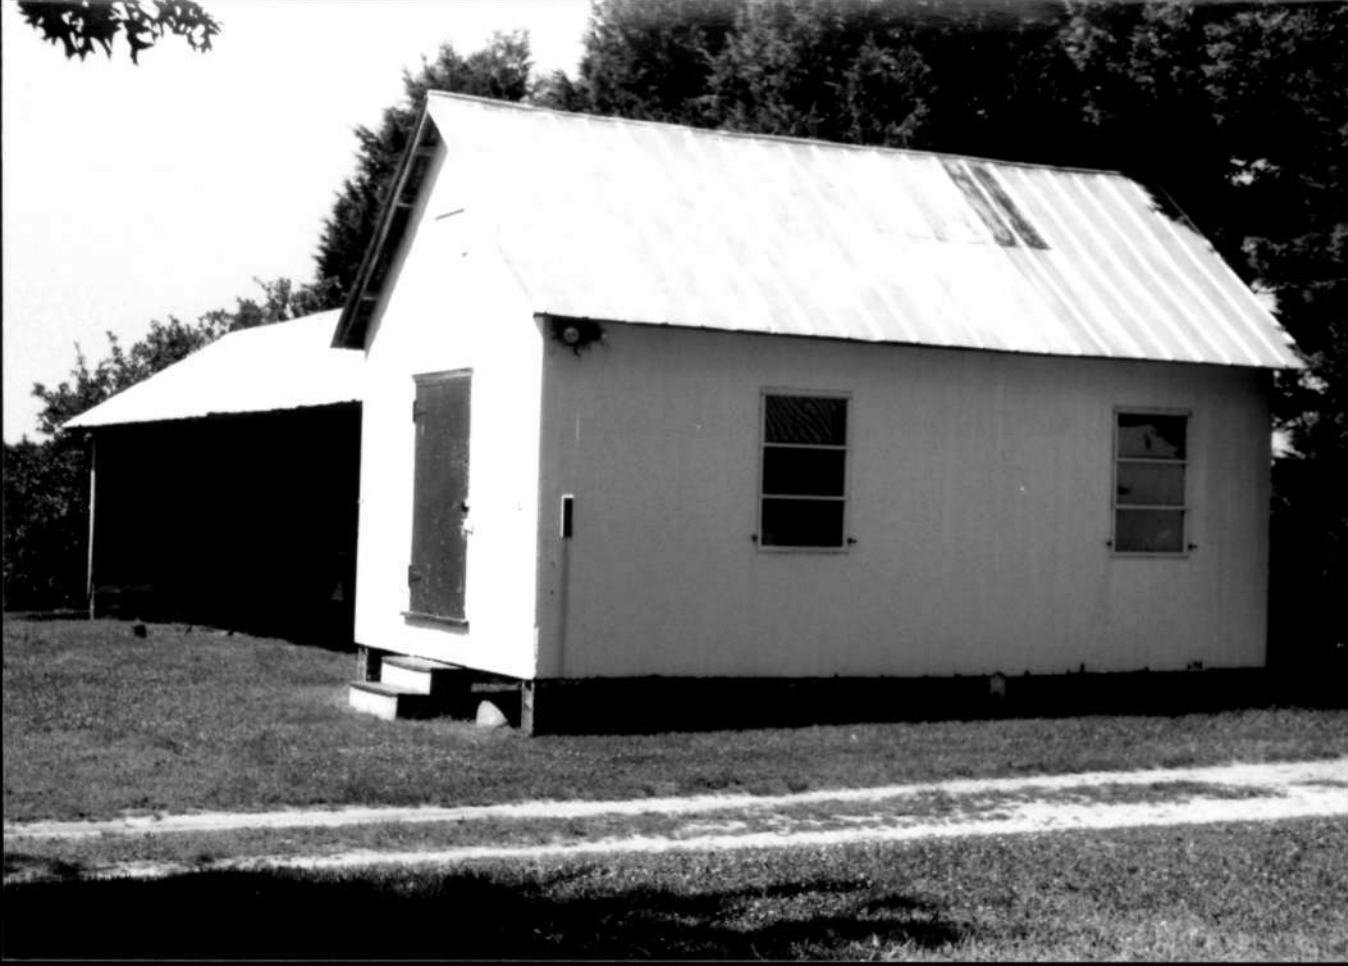
9/14

WAGON SHED + GRANARY looking W

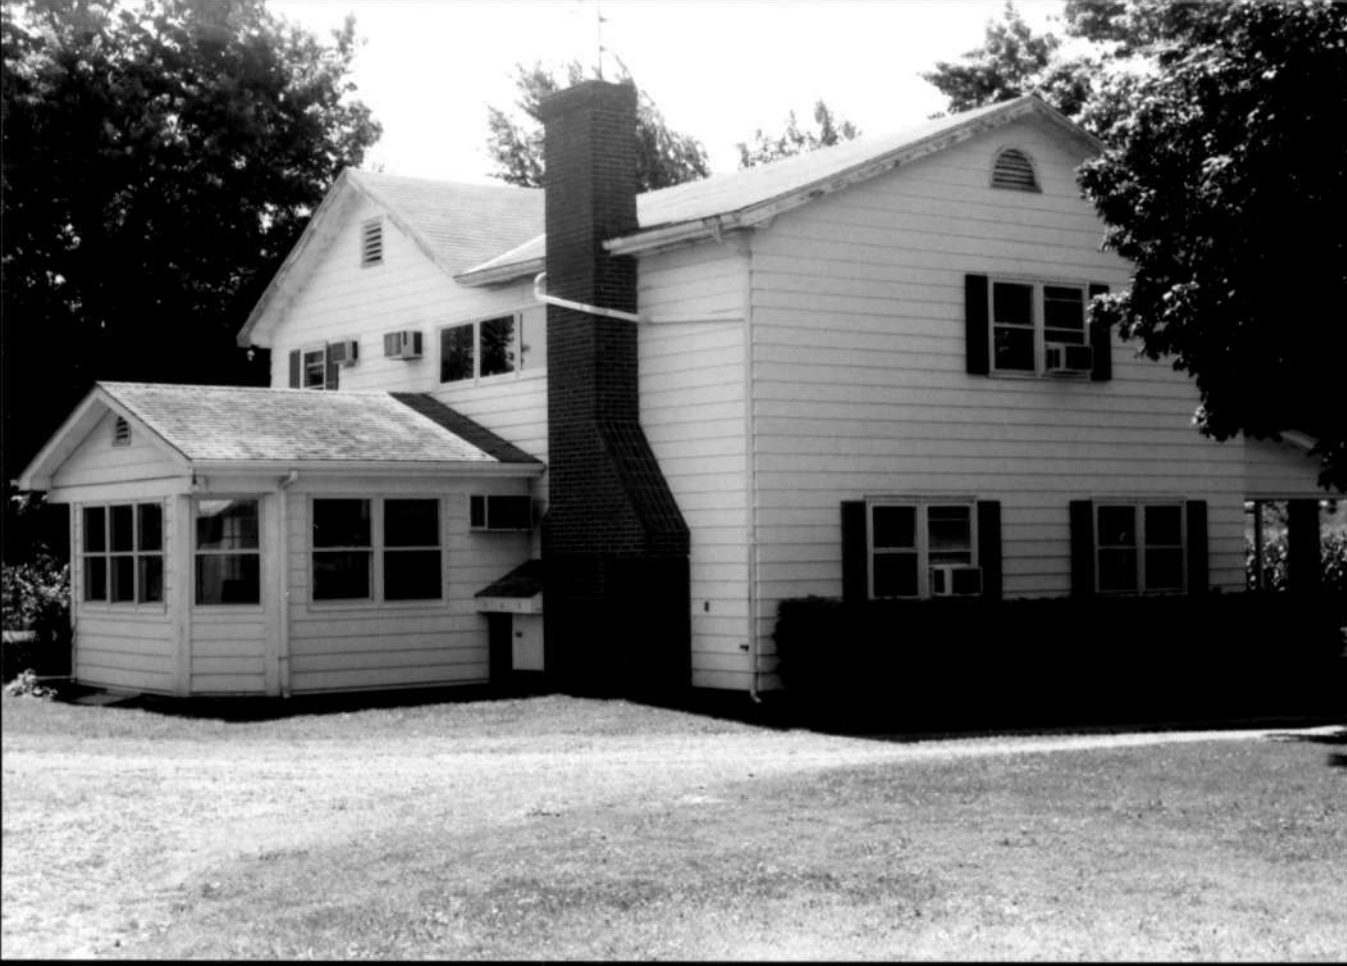
10/14

The residence is a two-story wood frame building, constructed ca. 1890, with significant twentieth-century alterations including side and rear additions. The building rests on a continuous brick masonry foundation and has a hall-parlor plan. The cross-gable roof is clad with asphalt shingles. The building has an exterior gable wall brick masonry chimney and an exterior side wall brick masonry chimney.

The north façade is clad with aluminum siding. The modern rear kitchen addition is a one-story projecting wing with a front-gable roof clad with asphalt shingles. The building is entered through a hinged two panel wood front door with nine-light sidelights on the rear addition. There is a two panel three-pane hinged wood door on the east addition which is used as a secondary entry. The windows are one-over-one vinyl sashes and single-pane vinyl casements. The rear porch has been enclosed and has a shed roof clad with corrugated metal.

MAIN HOUSE Looking S

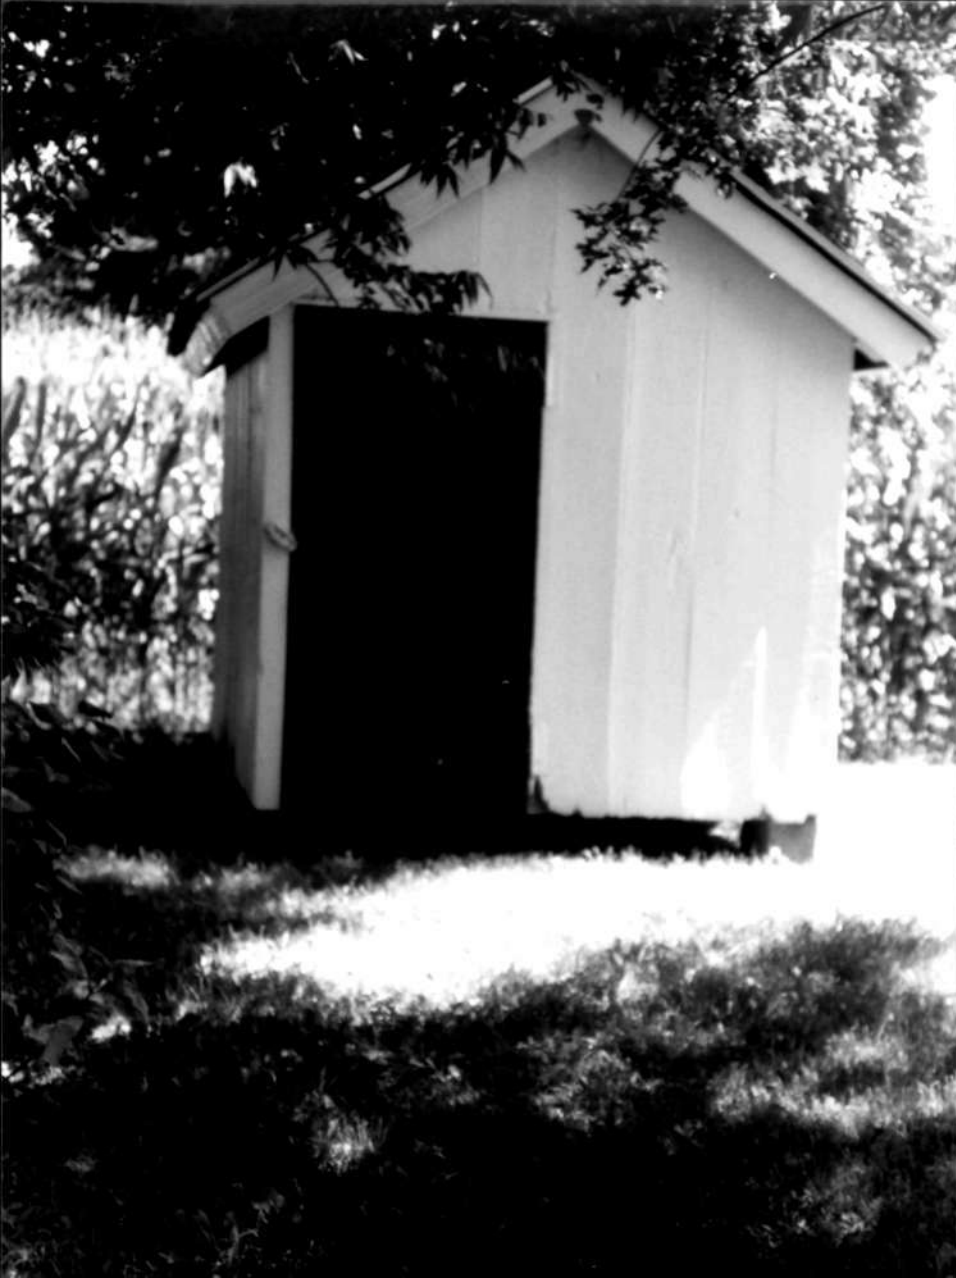
11/14

The smokehouse, constructed prior to 1937, is a one-story timber frame structure with an undivided interior space. The building rests on a continuous concrete masonry unit foundation. The walls are clad with twelve-inch vertical wood planks with metal battens added in 1946 to fill in the gaps between the planks. The front-gable roof is clad with asphalt shingles. The building is accessed through a hinged wood plank door on the south façade. There are no windows. The interior of the building is unfinished with an earthen floor. The building has been moved to its current location from elsewhere on the property.

SNICKER HOLE LOOKING NE

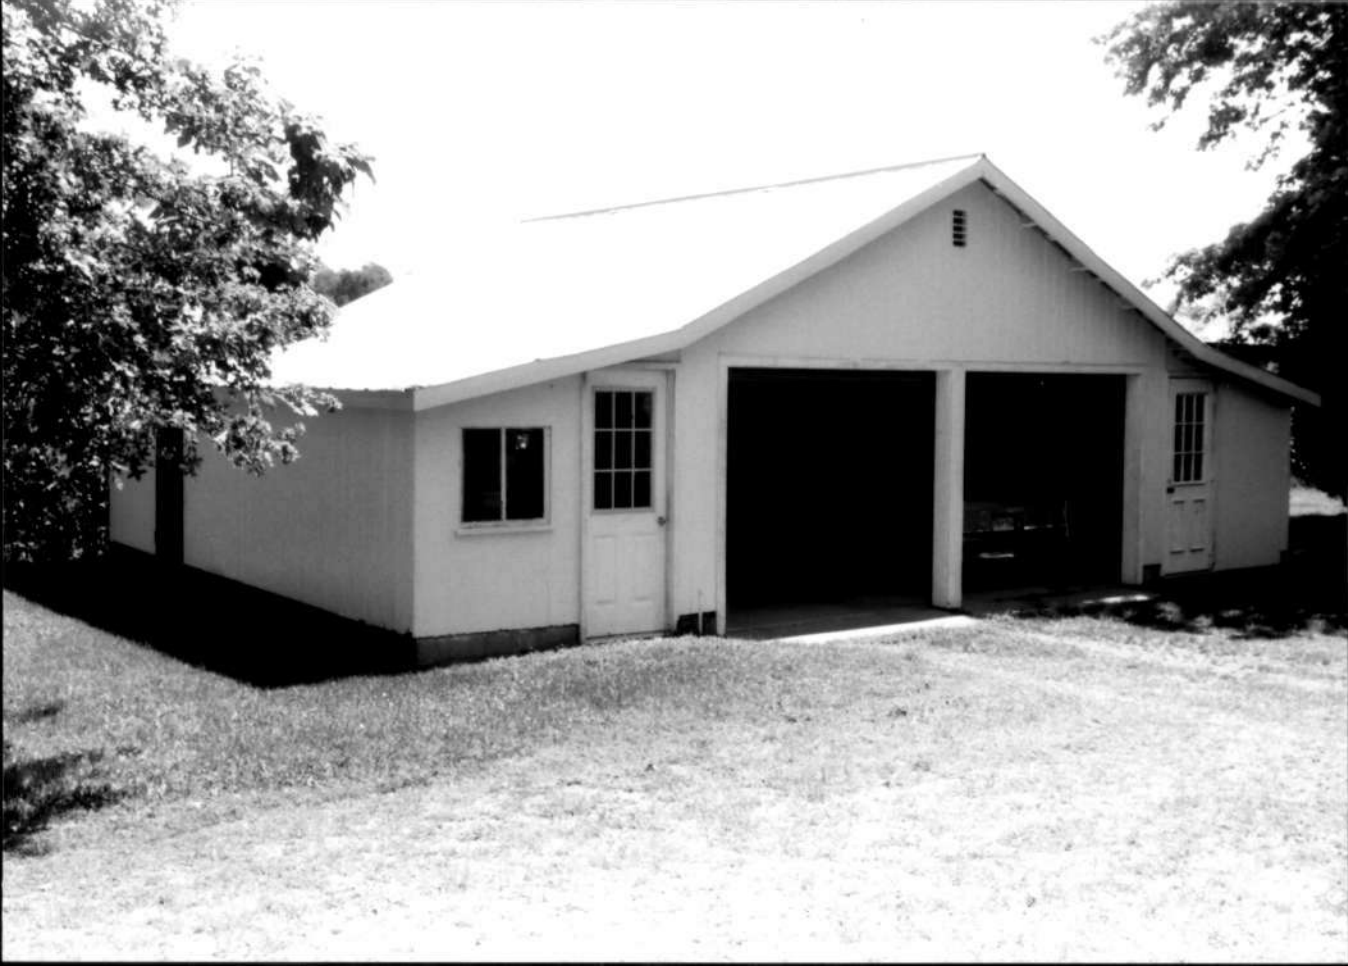
12/14

The garage, constructed ca. 1957, is a one-story light timber frame structure three bays wide with an undivided interior space. The side bays are used for storage and as a workshop space. The building rests on a poured concrete slab. The walls are clad with six inch vertical wood boards. The broken front-gable roof is clad with standing-seam metal. The building is accessed through two hinged two panel nine-pane wood doors on the south façade which flank the two large central rectangular openings for the cars. The rear doors are hinged plywood panels. The windows are six-pane and two-pane wood hopper sashes. The interior of the building is unfinished with a poured concrete floor.

GARAGE LOOKY E.

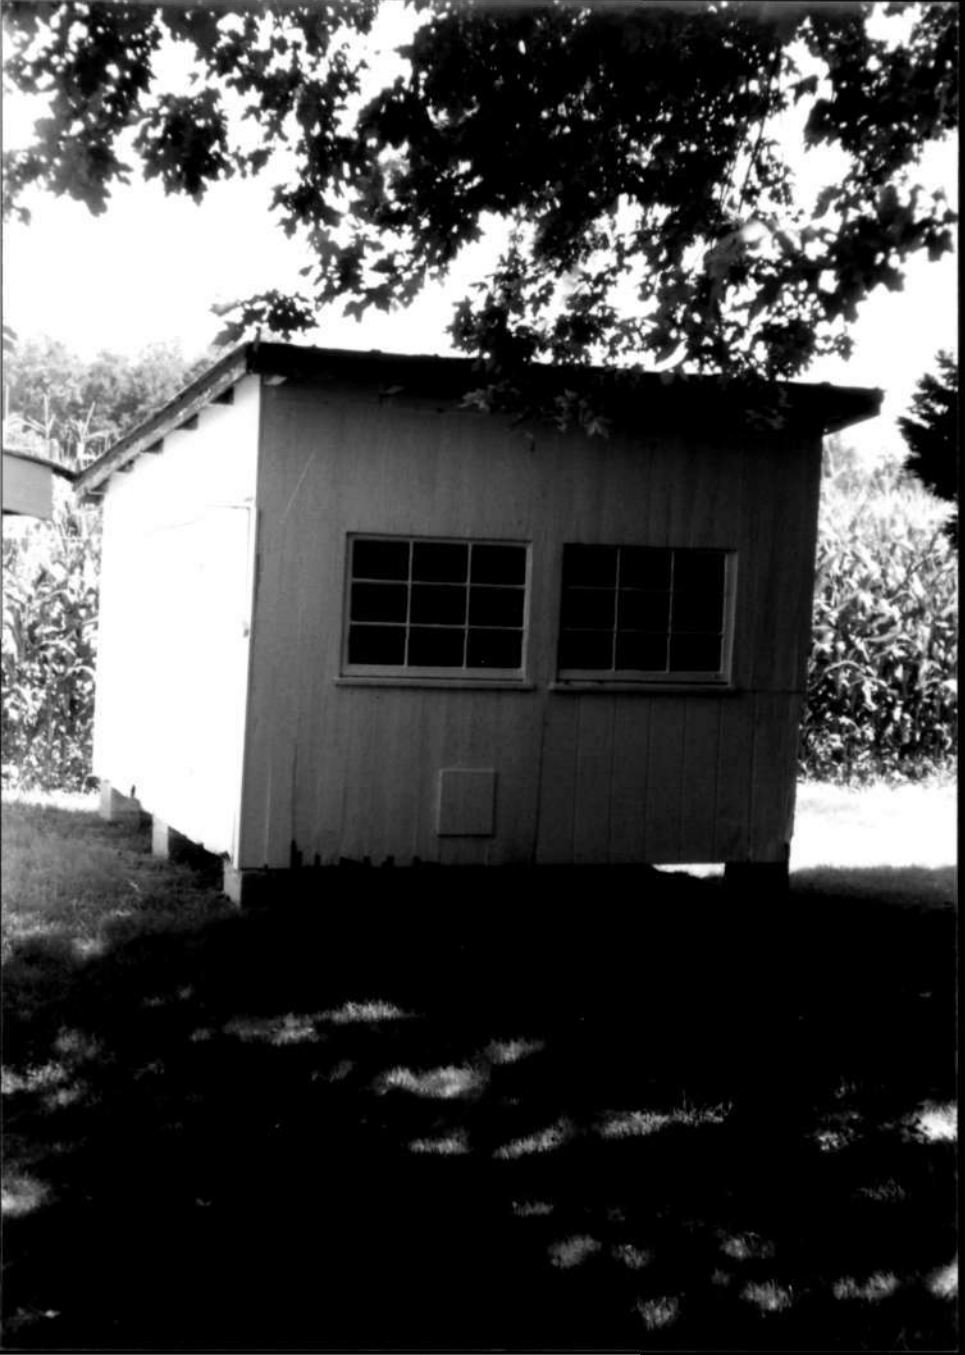
13/14

Adjacent to the garage is the hen house, constructed prior to 1937, which has been moved to its current location from elsewhere on the property. The building is a one-story light timber frame structure with an undivided interior space. The building rests on a concrete masonry unit pier foundation. The walls are clad with six inch vertical wood board. The shed roof is clad with standing-seam metal. The building is accessed through a hinged plywood panel on the north façade. The window openings have been infilled with nine-pane wood hopper sashes. The interior of the building is unfinished with a wood plank floor.

Broader House Looky E

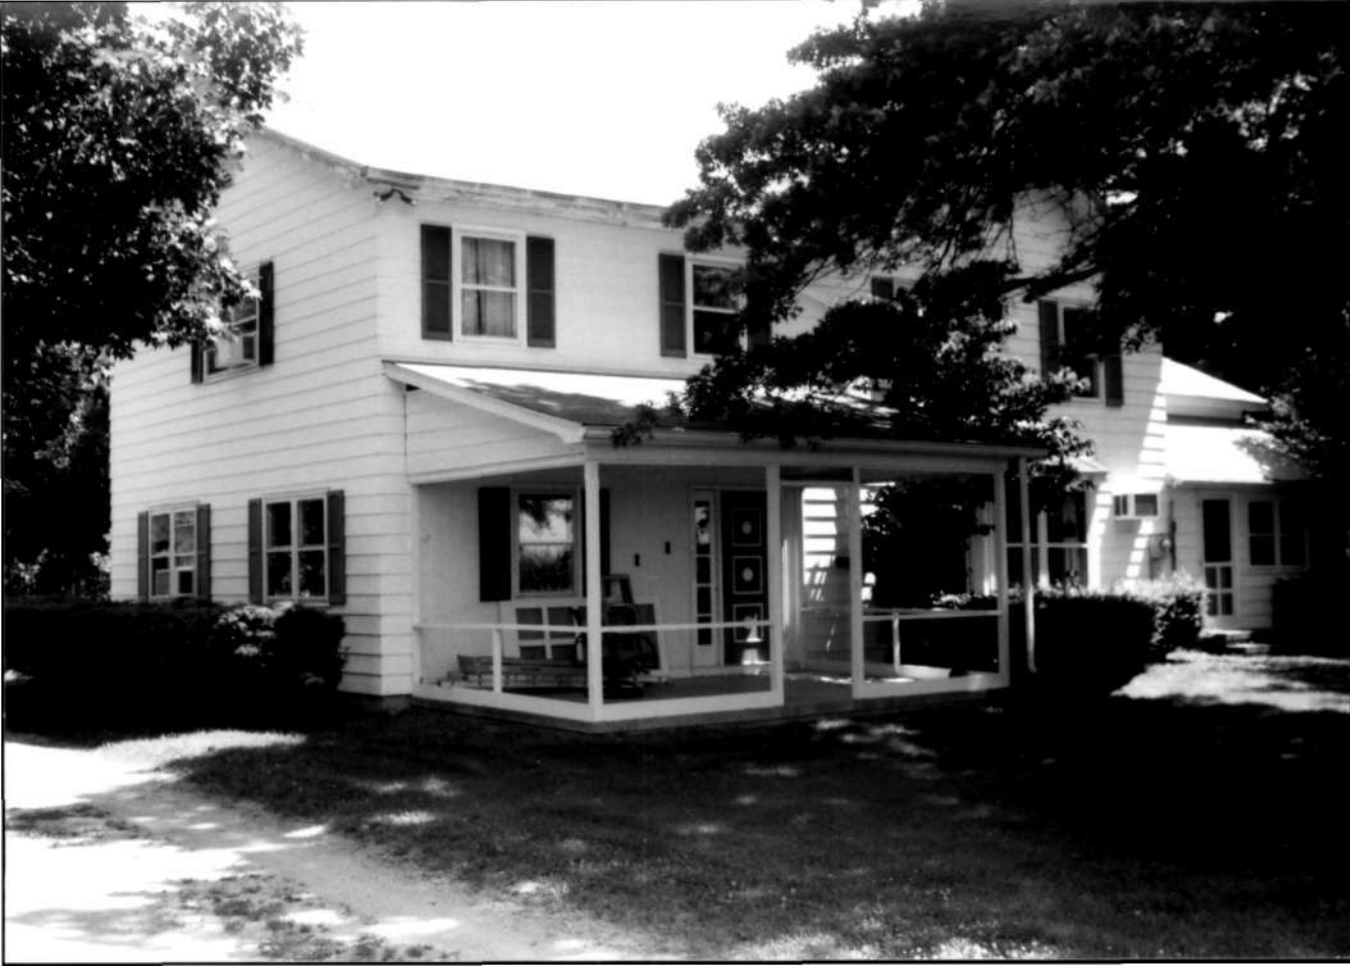
14/14

Main House Looking NE
